CASE STUDY 130

66 STORY SKYSCRAPER PARKING STRUCTURE

EXTERIOR ROLL-UP DOOR FOR QUICK OUTSIDE ACCESS AND HIGH SECURITY

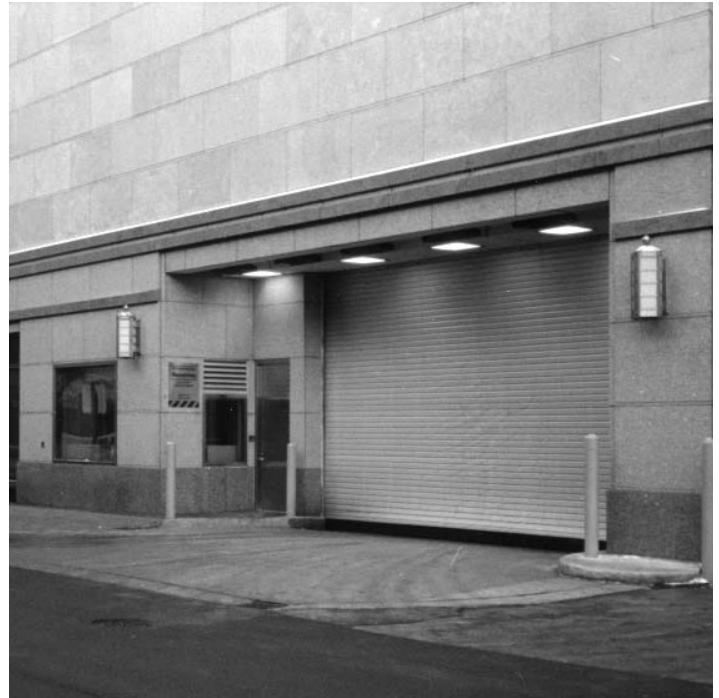
Working with the local ASI distributor, the fragile existing sectional door was replaced with a high speed Marathon **Hydrarol** hydraulic powered door.

This change has solved the doorway problems at this facility. The maintenance expense has been eliminated. Operating four times faster than the old door means that the doorway is fully accessible in just seconds. Along with the ability to avoid accidents, the speed of the door enables efficient handling of the several hundred truck trips through the doorway that occur daily.

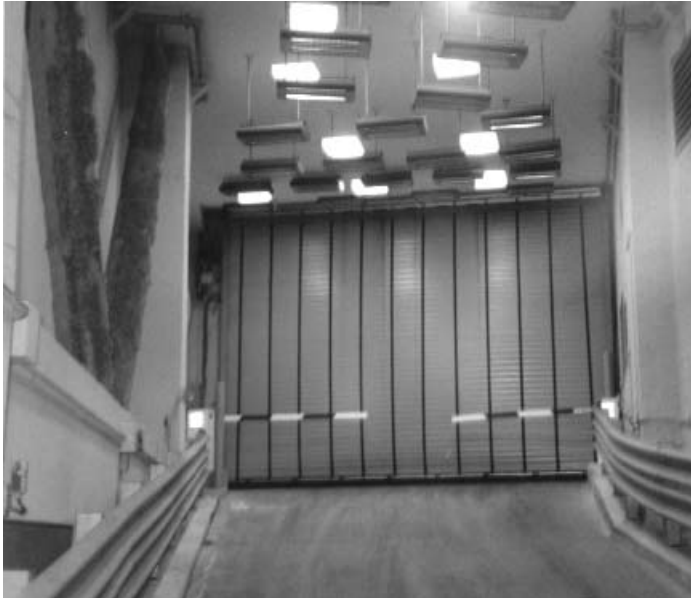
Unlike fabric doors that could deliver the necessary speed, the **Hydrarol** curtain is comprised of rigid slats. Each slat has an exterior aluminum shell and interior PVC shell to provide protection against criminal intrusion. And, what about those winds? A fabric door would become a huge

sail, slowing down considerably with a wind speed of over 25 mph. The **Hydrarol** door is designed to withstand high winds, thanks to its nylon windlocks and the door's rigid slats. Weather protection is provided as the **Hydrarol** is weathersealed along its entire perimeter. Plus, each slat is insulated to R-8.

With the wind factor and level of activity in and out of this facility, tremendous demands are put on the door operator, but the **Hydrarol's** patented hydraulic operator is specifically designed to take it. Warranted for five years, the U.L. listed operator is maintenance free, a major benefit, considering the amount of traffic the door is expected to handle. Because of the unique design of the **Hydrarol**, the operator delivers superior performance without the trauma of the high winds preventing the door from operating properly.
